TECHNICAL COMMUNICATION No. 02-200317 April 2003

**Subject: engine oil level****Model: Breva V750 i.e.****Frames involved: all**

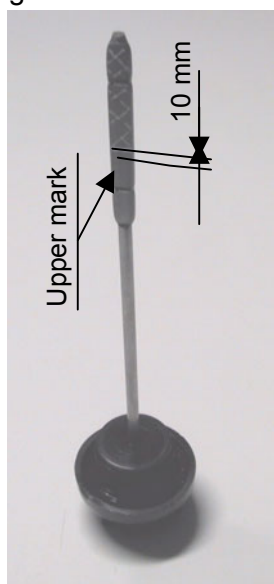
**Fault experienced on vehicle:** excessive quantity of oil extracted from the oil recover circuit.

**Main cause:** excessive quantity of engine oil.

An excessive quantity of engine oil can cause an increase in the oil extracted by the crankcase gas recover circuit. In exceptional cases an oil present in the transparent recovery tube, which extends from the filter housing to the rear joint of the right half cradle, type of anomaly can be experienced.

The checking operation can be easily carried out by using the oil filler cap dipstick. The correct quantity of oil wets the dipstick up to around 10-11 mm under the maximum level reference mark. The highlighted part in the photo shows the section of dipstick which must be wet. The check must be carried out with the engine warmed up, after around 20 minutes that it is running.

**Technical solution:** check and restore correct engine oil quantity (1.8 kg).

***Check the correct engine oil level to avoid this inconvenience.***

It may be useful to make a reference mark at the indicated quota, to facilitate the check during regular engine oil replacements.

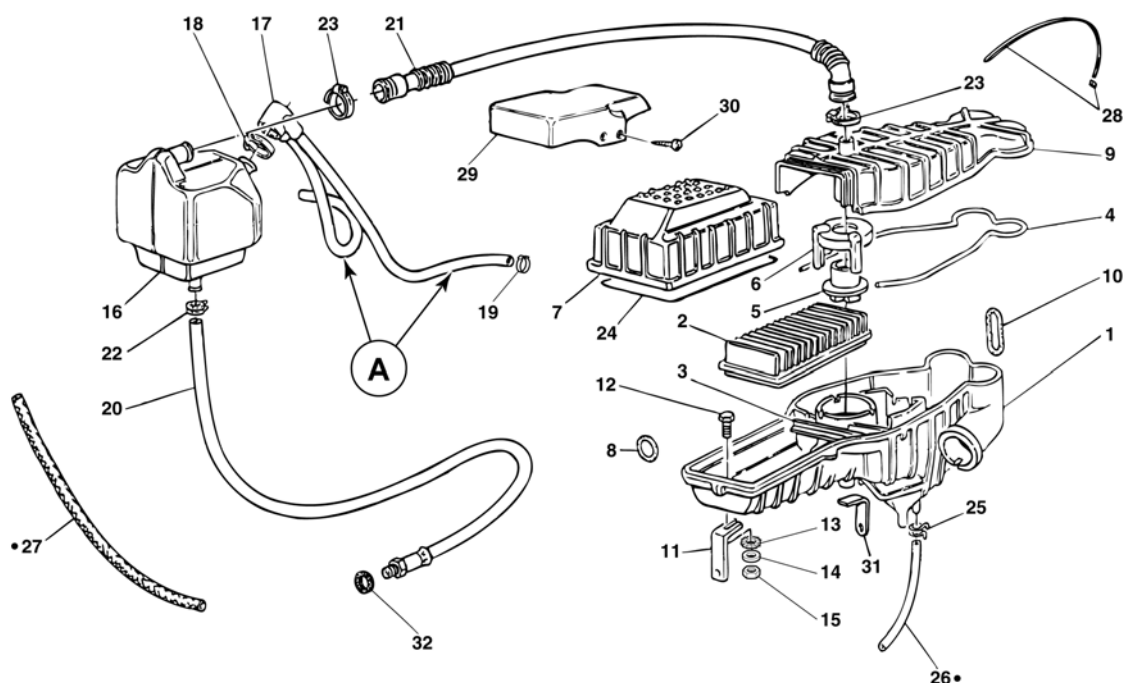
too much oil in the air box

The presence of oil in the decanter box and -following oil vapours circuit- in the air box has two main causes:

- too high oil level
- high pressure of the gases inside the crankcase

- Check that the two hoses (A) taking the oil vapours from the head covers to the decanter are not squashed due to their flexibility; if so, change them with more rigid hoses.

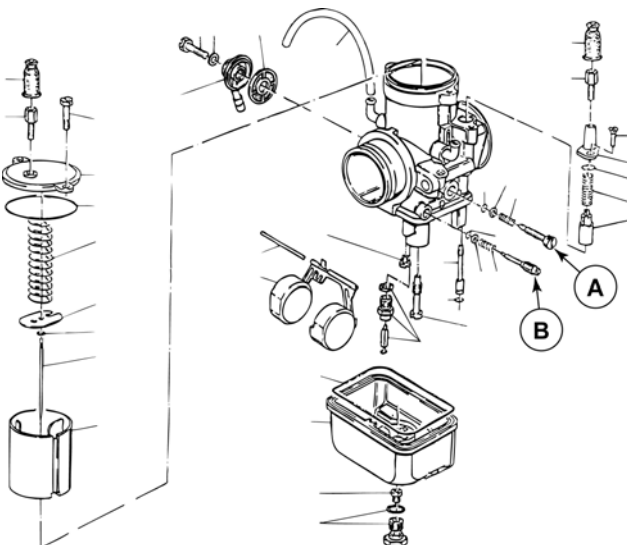
the problem might come out in different ways during a ride.

- Backfiring when releasing the throttle
- Erratic idling after acceleration
- Air leakage in the air box

- Check that the float needle valve (carburettor) is screwed in. If it is not so, change the gasket as per techn.bulletin no. 001-2003 dated 16 Jan. 2003 before tightening it.
- Connect the intake pipe take-up points to a vacuum meter.
- Start the bike and let it warm up to operating temperature.
- Set idling speed to  $1150 \pm 50$  rpm.
- Balance the cylinders, make sure that idling speed stays the same. The idling speed adjusters (**A**) are the same that are used for balancing the vacuum on the intake pipes. It is necessary to slightly rev up, using the throttle grip, and balance the vacuum in the intake pipes using the threaded adjusters. Check that the play of the throttle drive cable is 1 mm at idling speed.
