## GEAR CHANGE PAWL SPRING

**Subject: broken gear change pawl spring**

Model: V11

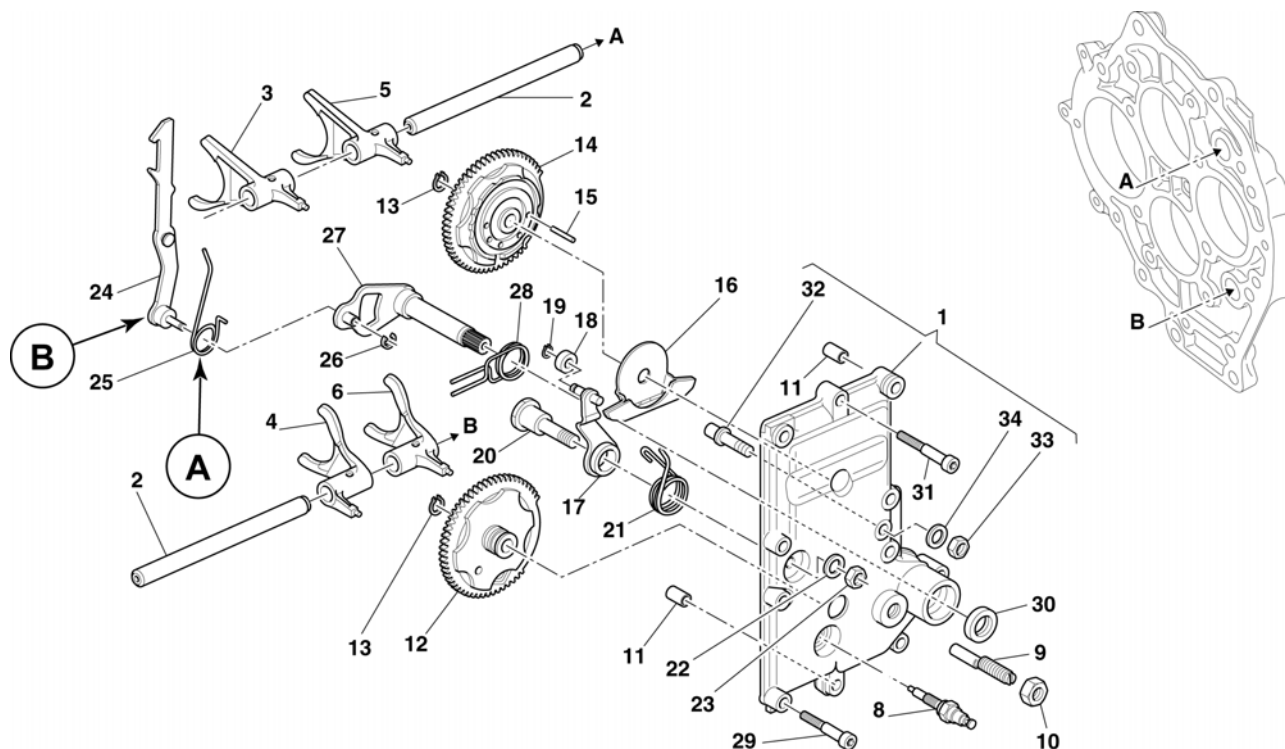
broken gear change pawl spring

In case of breakage of the pawl spring (A) in vehicles with frame numbers before **KT111435 - KS112350**, the pawl (B) should be changed (when asking for the spare part, you automatically receive the pawl updated version).

The change consists in the reduction of the diameter on which the spring rests from 16 mm to **15 mm**.
