**TECHNICAL COMMUNICATION No. 02-2003****17 April 2003**

**Subject: engine oil level****Model: Breva V750 i.e.****Frames involved: all**

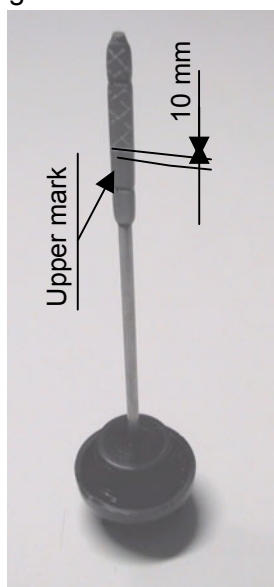
An excessive quantity of engine oil can cause an increase in the oil extracted by the crankcase gas recover circuit. In exceptional cases an oil present in the transparent recovery tube, which extends from the filter housing to the rear joint of the right half cradle, type of anomaly can be experienced.

The checking operation can be easily carried out by using the oil filler cap dipstick. The correct quantity of oil wets the dipstick up to around 10-11 mm under the maximum level reference mark. The highlighted part in the photo shows the section of dipstick which must be wet. The check must be carried out with the engine warmed up, after around 20 minutes that it is running.

**Technical solution:** check and restore correct engine oil quantity (1.8 kg).

***Check the correct engine oil level to avoid this inconvenience.***

It may be useful to make a reference mark at the indicated quota, to facilitate the check during regular engine oil replacements.
